A/CZ0046/2/0013 ASSESSMENT OF HISTORICAL IMMOVABLES
www.heritage.cvut.cz

Climate, environment and frost damage of architectural heritage

S. Kyllingstad, T. K. Thiis, A. Flø & J. Potac

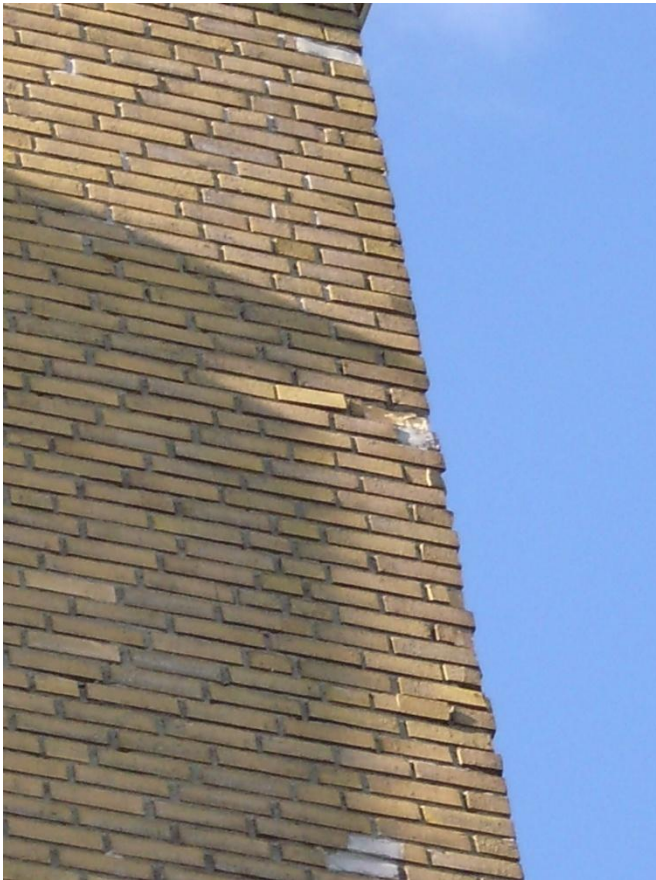
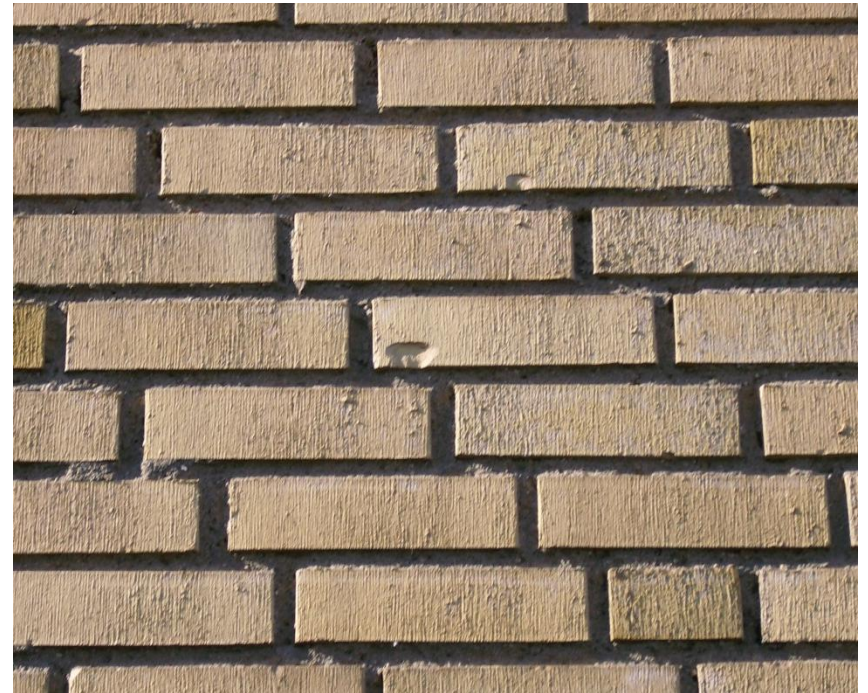
- **Porous building materials contain water**
- **When water freeze, internal stress build up in the material and can cause flaking of the material**
- **Important factors in the rate of deterioration are**
 - Water content in the material
 - Number of freeze-thaw cycles (approximately 70 pr. year in Oslo, Norway)

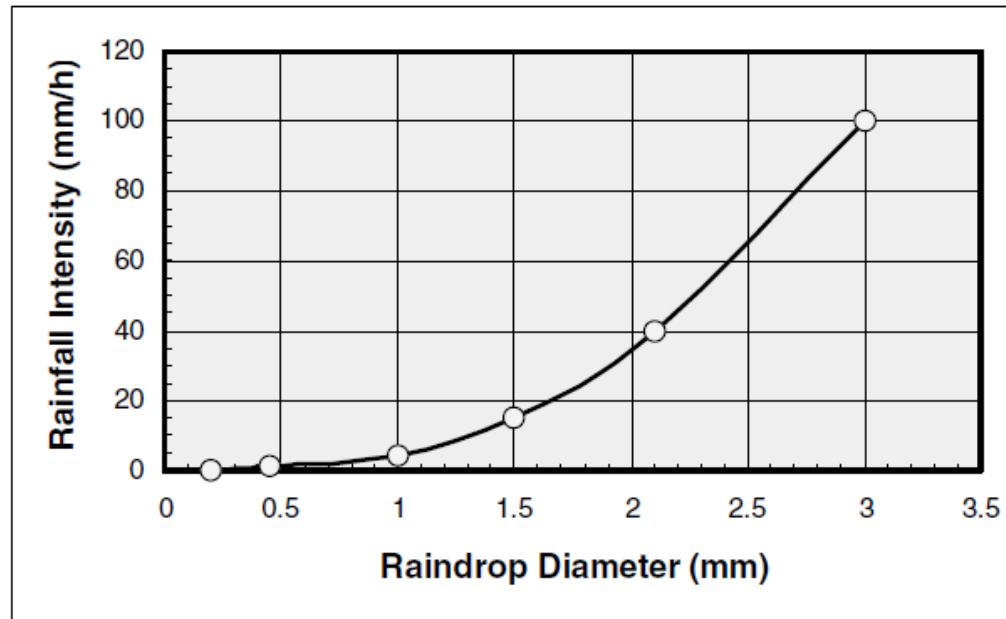
- As rainfall intensity increases, so does the mean raindrop diameter

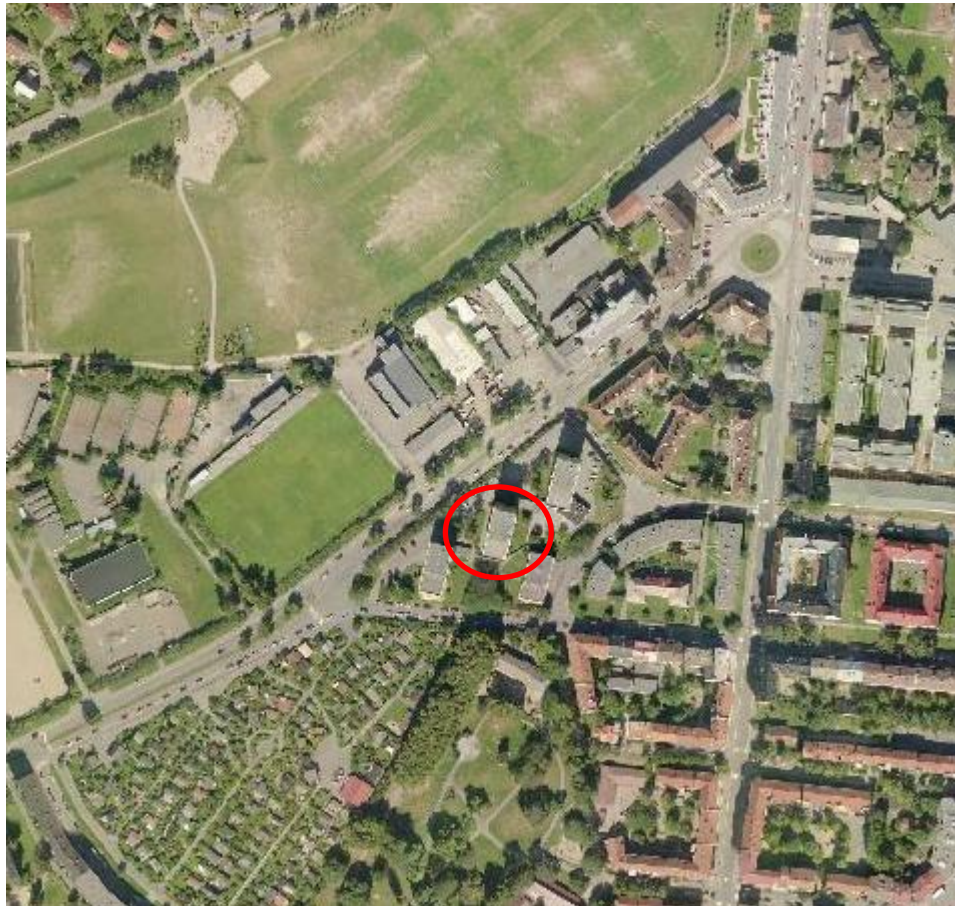
- **Case study, Stavangergata in Oslo, Norway**

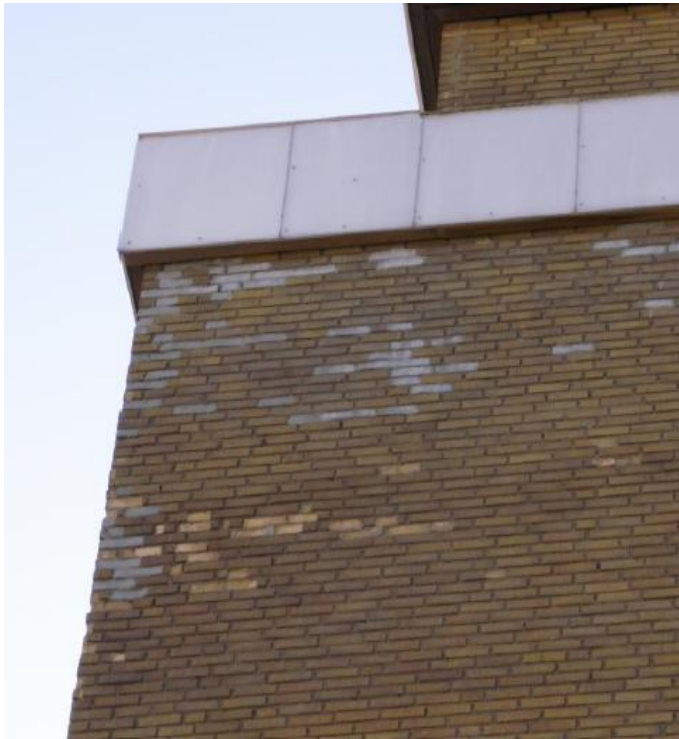
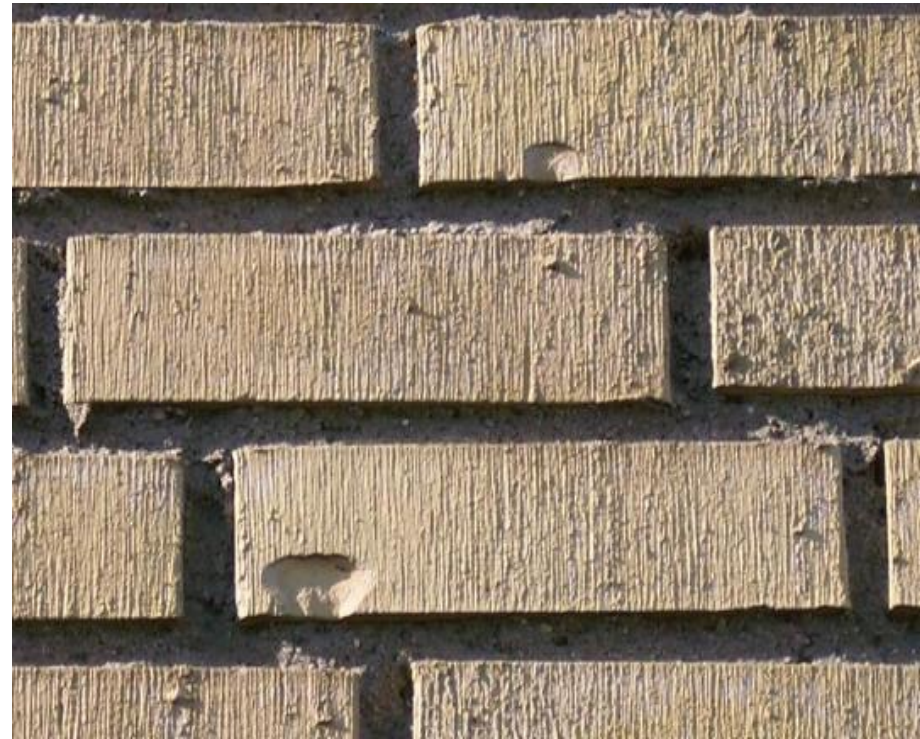
- **Damage characterisation**
 - Identify damages from pictures
